# ESSAY #1

## WI-FI TROUBLESHOOTING IN A COOLER WAREHOUSE

BY FRANÇOIS VERGÈS  
CWNE APPLICANT

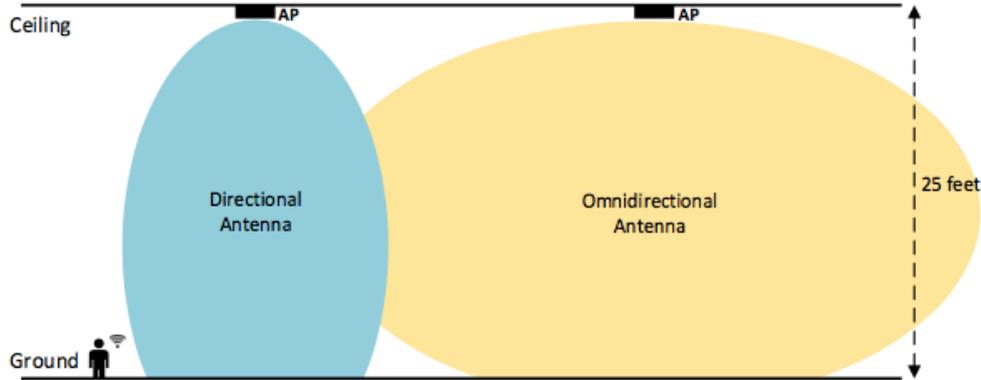
As expected, the use of directional antenna did not necessarily improve the coverage on the ground, however, it contained the signal by directing it downside. This way, the signal was not affecting other APs as much. Here is an illustration explaining the phenomena:

So I decided to perform some testing using a directional antenna in order to try to focus the RF signal only where needed. To do so, a directional antenna with a gain of +6dBi from Cisco was used. The transmit power was set to 13dBm. This was the maximum I could use if I wanted the power to be symmetrical between the APs and the clients. However, this was higher that what I had configured for most of the APs previously. Since the RF was going to be more focus, I could go a little higher without having to worry about creating too much CCI.

The results of these testing were good and the customer decided to purchase a few of these directional antennas to use in the warehouse. Seven (7) of the eleven (11) access points ended up using these new type of antennas. Moreover, one (1) access point was relocated and moved about 15 feet from its original location to better take advantage of these new antennas.

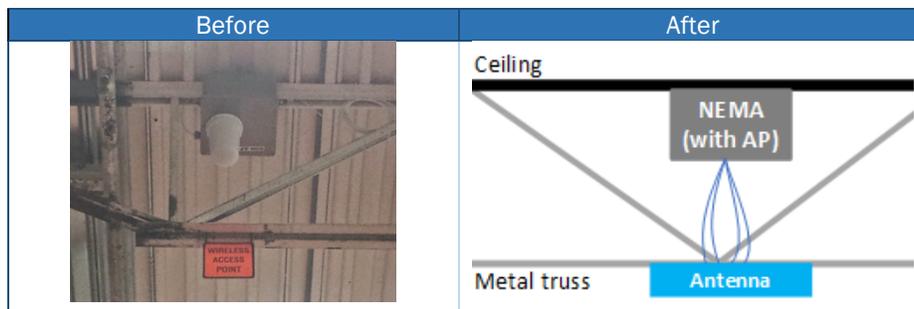
- The antennas were, sometimes, installed right under the ceiling steel structure resulting in an direct obstruction of the signal as soon as it was leaving the antenna.

On top of these new changes, I have advised the customer to change the installation of their antennas in order to fix the previous situation where ceiling metal truss were obstructing the signal as soon as it was leaving the antenna. I recommended to install the antenna below the metal truss as shown in the diagram below:

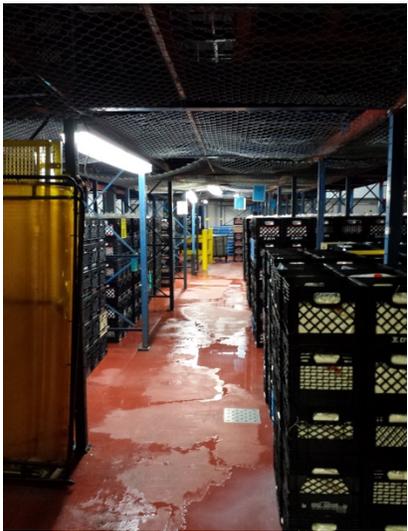
- Some workers were working in galleries located underneath the racks surrounded by milk. The initial site survey, performed before the new installation, has not taken these galleries into consideration. Therefore, Wi-Fi coverage was really bad.

Gallery under racks

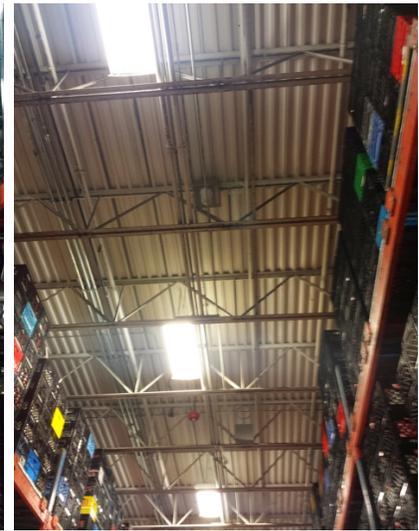
Example of bad antenna installation
